Residential high rise evacuation

Residential high rise above shopping centre

Gas explosion takes out lifts

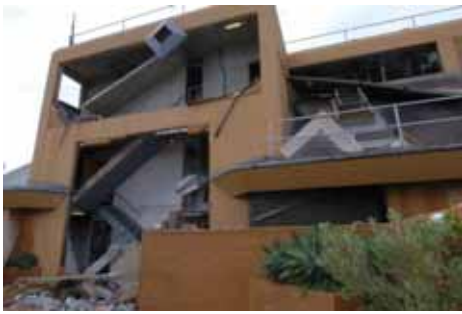
Damage to plant areas

On 30 March 2009 a gas explosion occurred on level 29 in the plant room area of a residential high rise building in Spring Street, Bondi Junction, where two plumbers were working on a gas fired water heater.

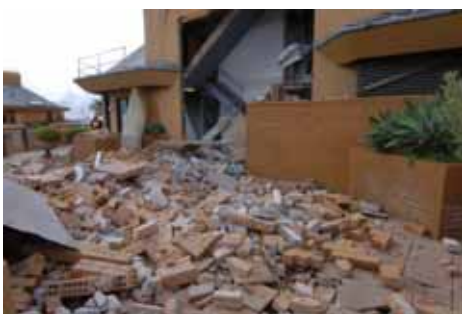
Masonry walls blown out

The building has a reinforced concrete frame with non-load bearing masonry walls. Walls were blown out on the top two levels. There were cracks in the stairwell at level 26, getting progressively worse further up.

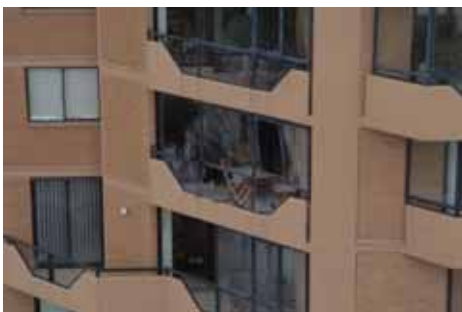
Windows blown out of units

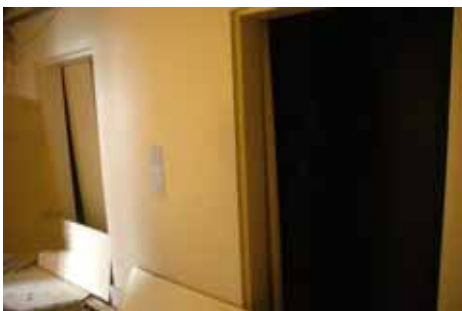
Lift doors blown out

There was no ongoing fire, but the blast wave travelled down a riser and blew in most of the doors on levels 23 and above, including the fire stair and lift doors. The blast made the lifts inoperable.

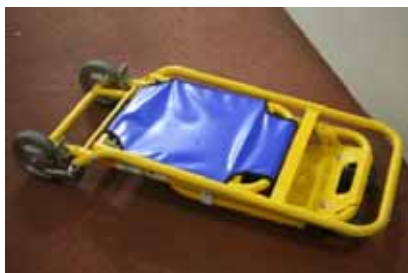
Ambulance Service folding chair
- folded

Firefighters used chairs to carry residents down the stairs. The Ambulance Service provided some folding chairs which were very useful. Stretchers were not used, as they would have been too difficult to manoeuvre on the narrow stairs.

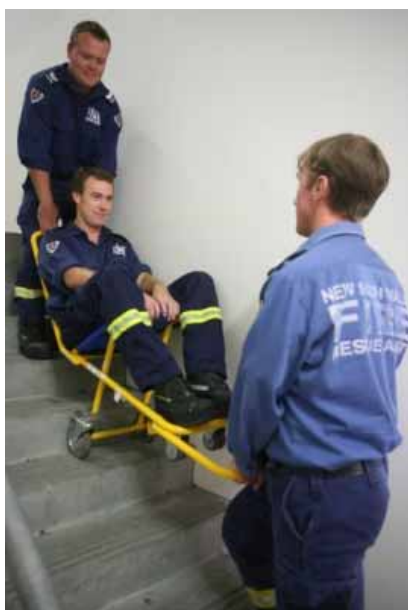
Firefighters from 1 City of
Sydney B Platoon demonstrate
using the chair

Generally, four firefighters were needed to carry someone down the stairs in a chair. It could be done with two, but the people being carried felt safer with four. However, in the narrow stairwell this meant firefighters had to exercise care not to scrape themselves on walls and corners.

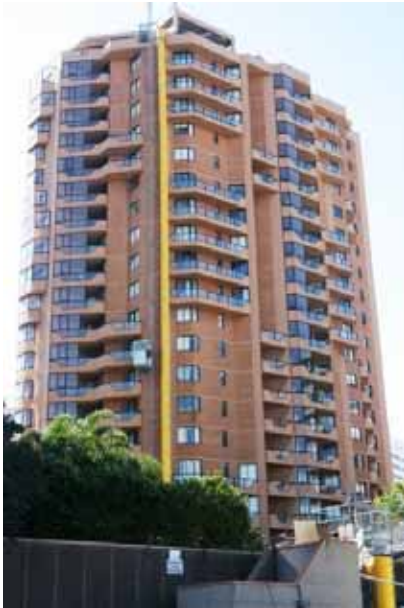
Repair work will take some months to complete

Unfortunately for the residents, the building was declared uninhabitable. At the time of writing, it appears that they will not be able to return to their homes for some months until structural work on the building is completed and lifts and utilities restored.
